AFML-TR-77-212

CHARACTERIZATION OF REACTION SINTERED SILICON NITRIDE RADOMES

TECHNICAL REPORT AFML-TR-77-212
Final Report for Period 1 January 1977 — 1 September 1977

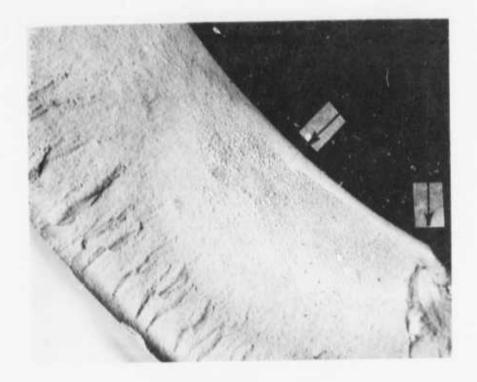
radomes. On each fracture surface there are flaws which are large compared to the 100 to 200 micron flaws which were the sites of initial fracture in flexure bars used to measure the strength of the radome material. These large flaws, which could have initiated fracture, include internal voids and inclusions, extended regions where the prefracture bond strength across the fractured surface was apparently weaker than in the bulk, and large chips, cracks and laminations on the inner surface.

The origins of fracture are not clear since fracture mirrors and associated features which often permit unequivocal identification of a fracture origin were not observed. There are, however, ridges radiating to the outer surface from flawed areas which may be an indication that fracture initiated at the neighboring flawed area. The small pieces of material recovered from the wind tunnel were inspected for fracture mirrors and other markings, but nothing significant was found.

Figure 1. The fracture surface of Radome 1. (a) 4X. (b) 0.5X. The arrows indicate flaws that could have initiated fracture.

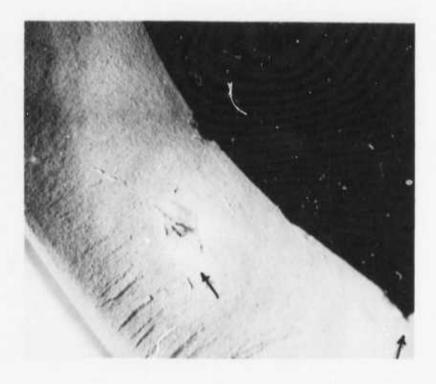
Figure 2. The fracture surface of Radome 2. (a) 3.5X. (b) 0.4X. The arrows indicate flaws that could have initiated fracture.

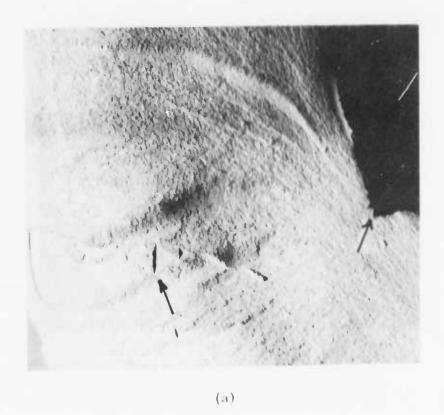
Figure 3. The fracture surface of Radome 3. (a) 6X. (b) 0.5X. The arrows indicate flaws that could have initiated fracture.

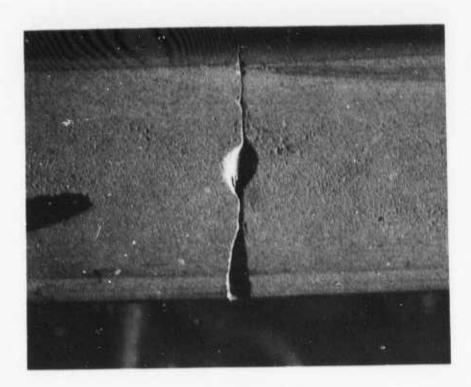
Figure 10. Fracture surface (a) and tensile surface (b) of flexure bar 3-3B.
